Maintaining The MWA's Electronic Systems

December 2020

Presented by Phillip Giersch, Curtin University/MWA

Beamformer Upgrade Project 2020-2021

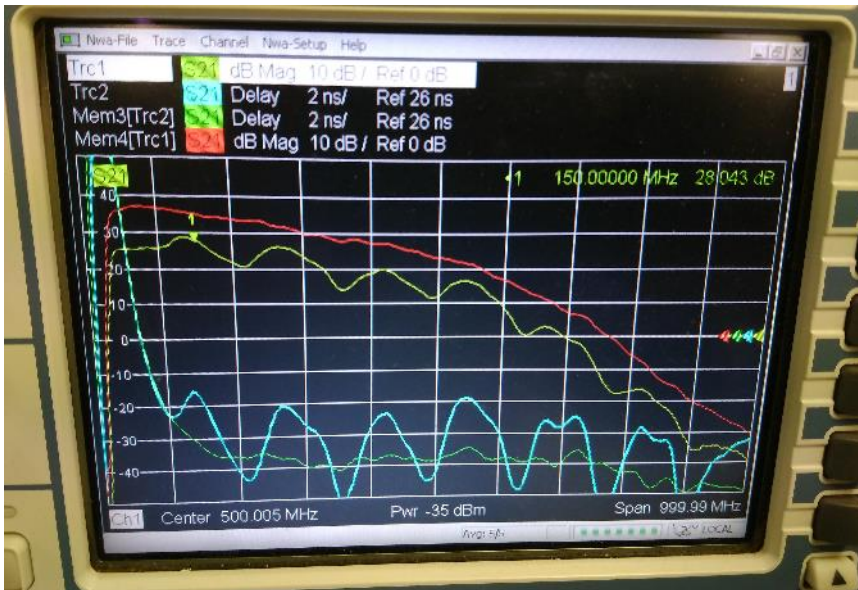
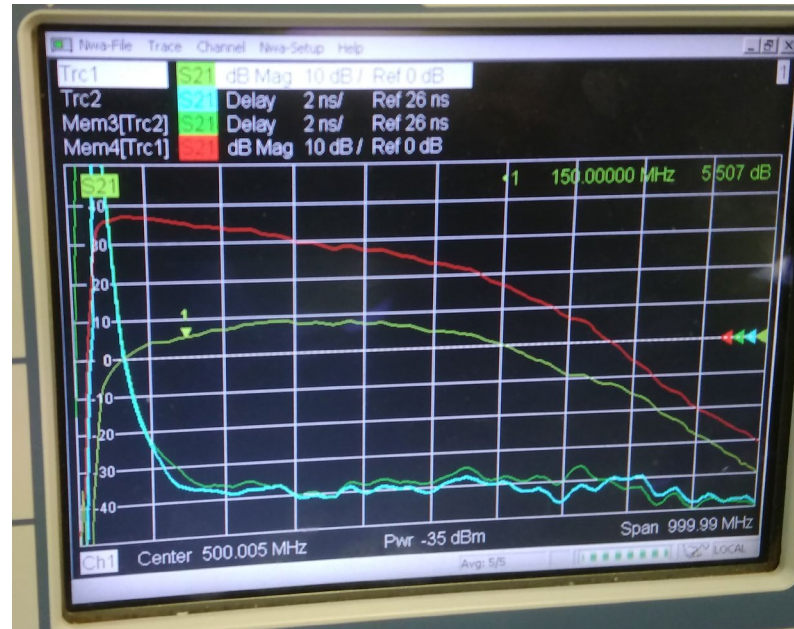
General Faults

- Can Be Caused by cracked Capacitors failed inductors Leaking RF switches damaged summing transformers

Severe example with Distortion in Both Gain And Delay on a single channel

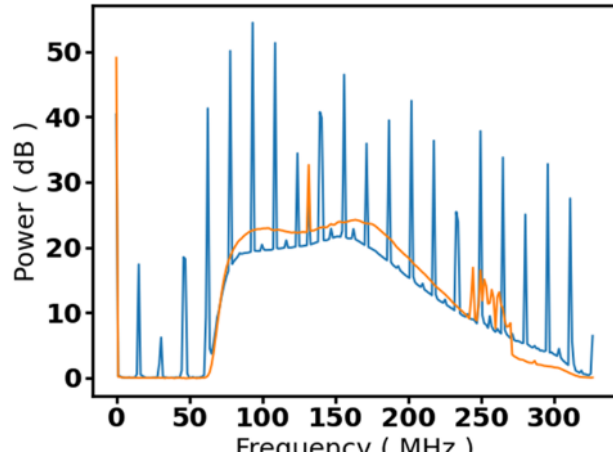
Rx: 6 Slot: 4 Polarization: X Recorded at 2020-06-22 03:16:34
Rx: 6 Slot: 4 Polarization: Y Recorded at 2020-06-22 03:16:35

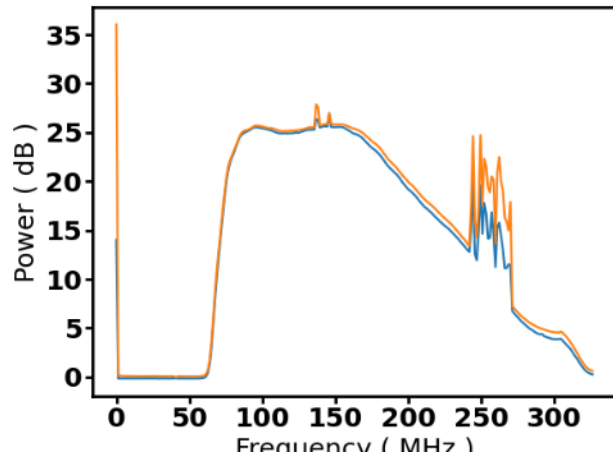
Rx: 10 Slot: 1 Polarization: X Recorded at 2020-06-29 03:44:44
Rx: 10 Slot: 1 Polarization: Y Recorded at 2020-06-29 03:44:45

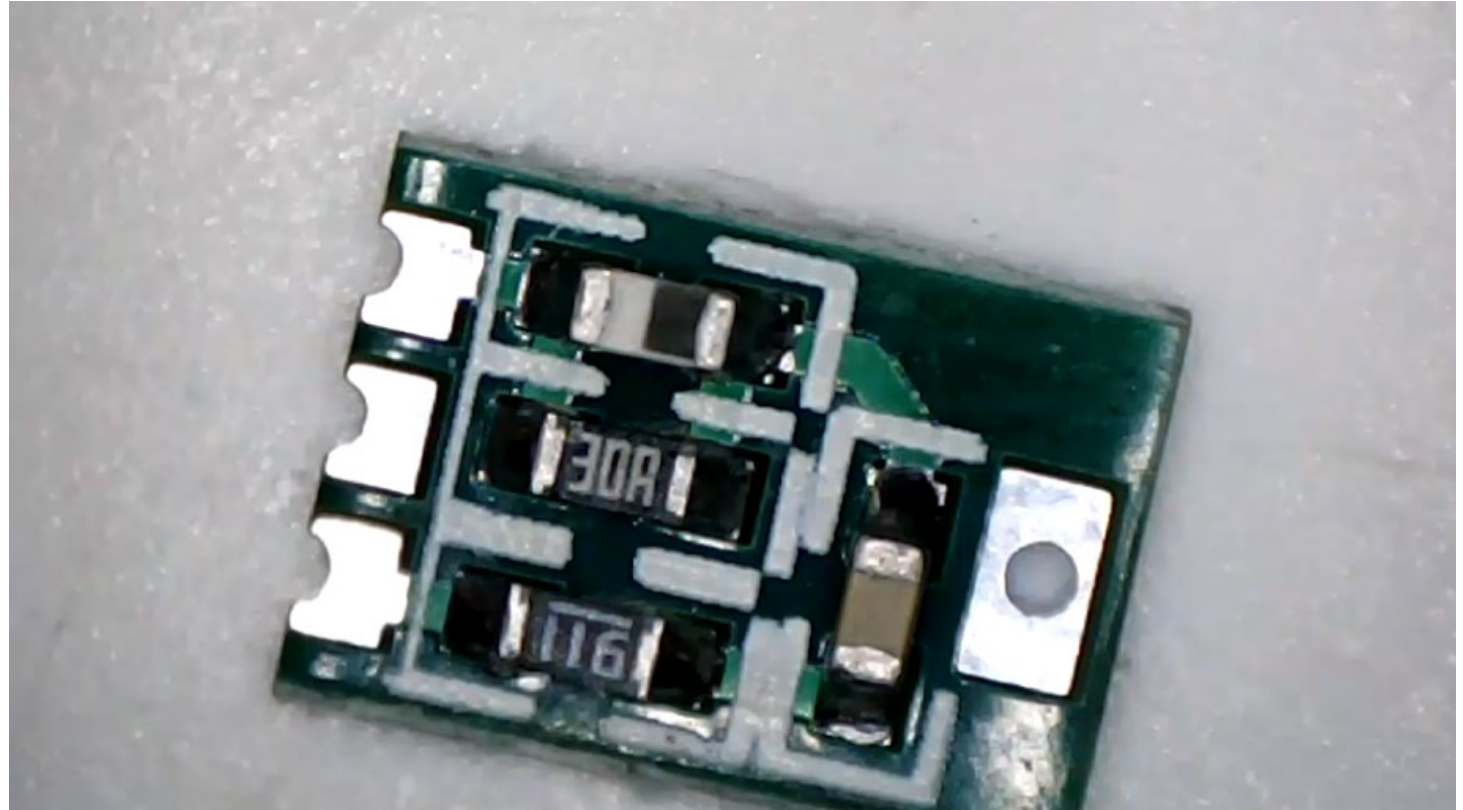
Micro fractures in daughter board capacitor

- Causes
 - Thin PCB substrate
 - Depanelizing Process
 - Capacitor position on PCB
- Exacerbated by
 - Temperature shifts.
 - Movement.
 - Rework.
 - Handling.

New Flex term capacitors fitted to all existing and future daughter boards

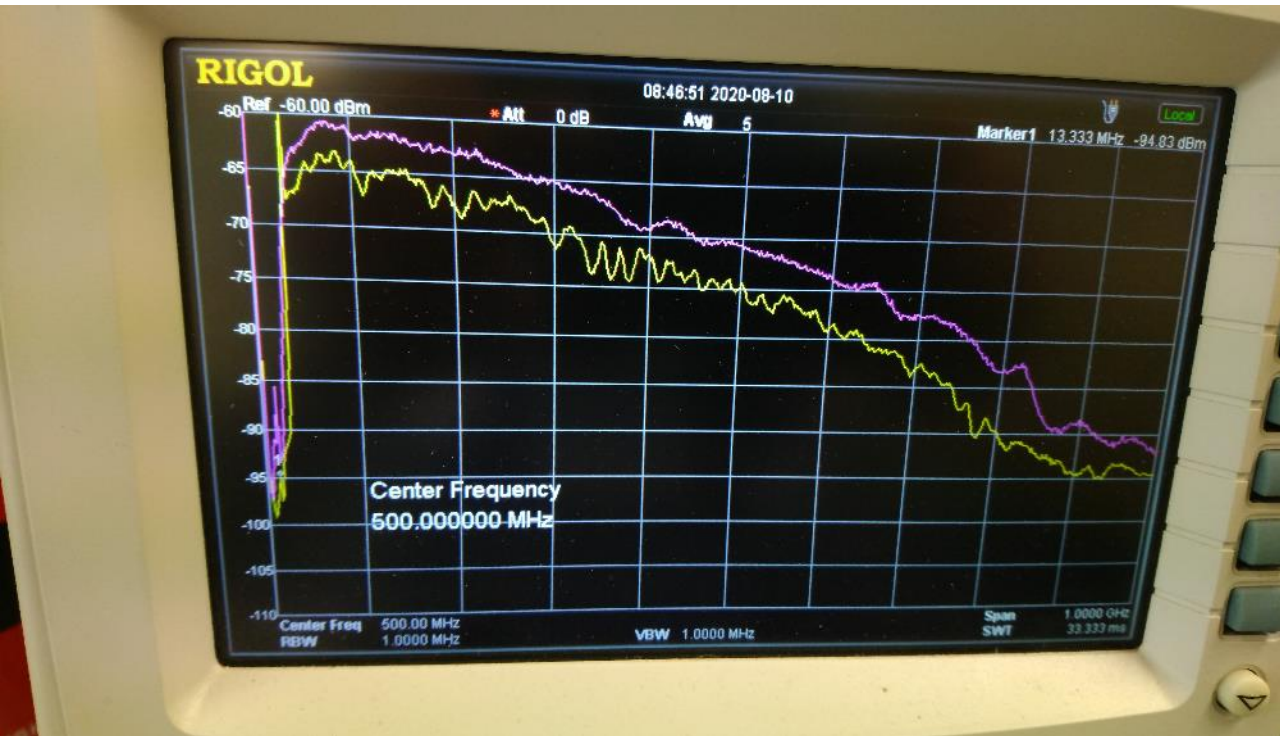
Closed Box Spike

- -60db Spike generated between 0 and 100MHz
- Only observed when the beamformer enclosure is closed

Spike Shown on Spectrum analyser
