POWER-UP ISSUE WITH APIU

This document discusses an issue discovered with the APIU as installed at the AAVS1.1 antenna station, and proposes actions to remedy this issue.

This document applies to at least the APIU installed at AAVS1.1 but may extend to all APIUs of the same version installed on the MRO site.

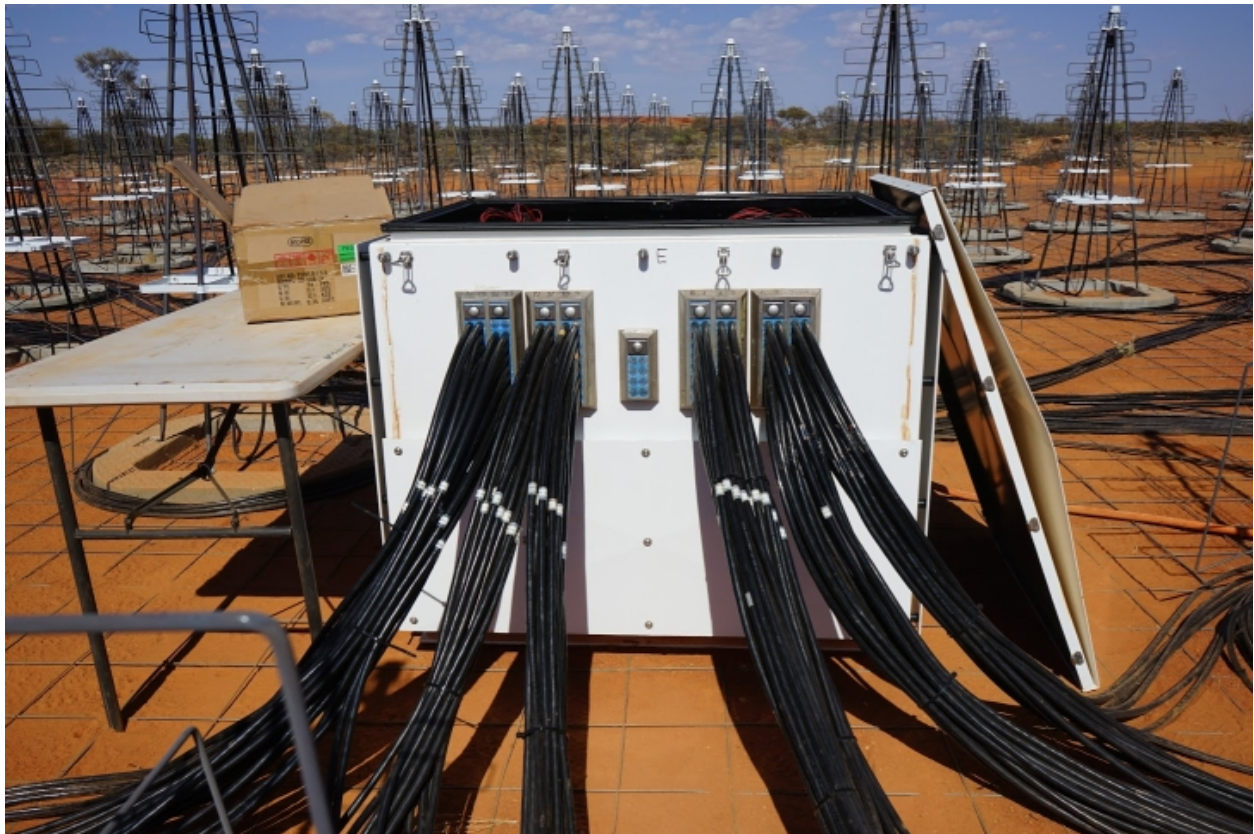
FIGURE 1: NORTH FACE OF APIU ON AAVS1.1 ANTENNA ARRAY

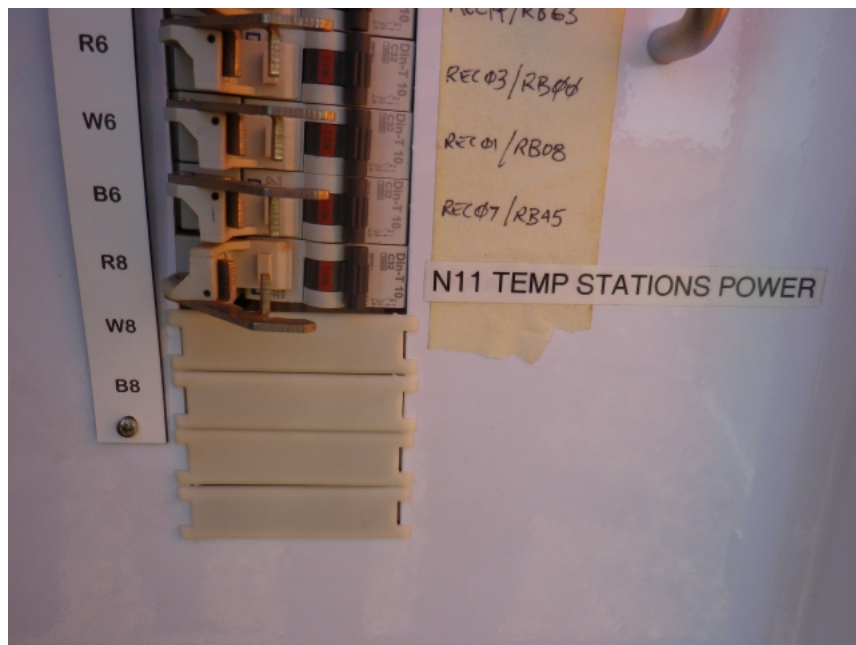
MWA Field transformer kiosk: DIN-T10 C32, 10kA breaking capacity, "C" curve, 32A breaker.

FIGURE 2: MWA FIELD TRANSFORMER KIOSK SHOWING AAVS BREAKER “N11...”

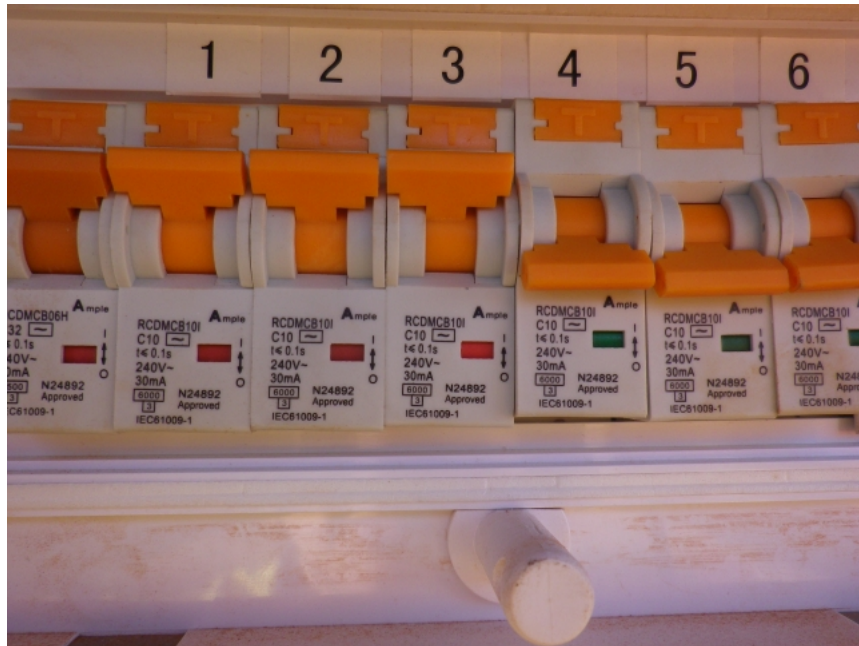
AAVS power distribution sub-board: RCDMCB10I-C10 => 6kA breaking capacity, "C" curve, 10A breaker, 30mA RCD combo.

FIGURE 3: AAVS1 POWER DISTRIBUTION SUB-BOARD BREAKER PANEL SHOWING BREAKER "3"

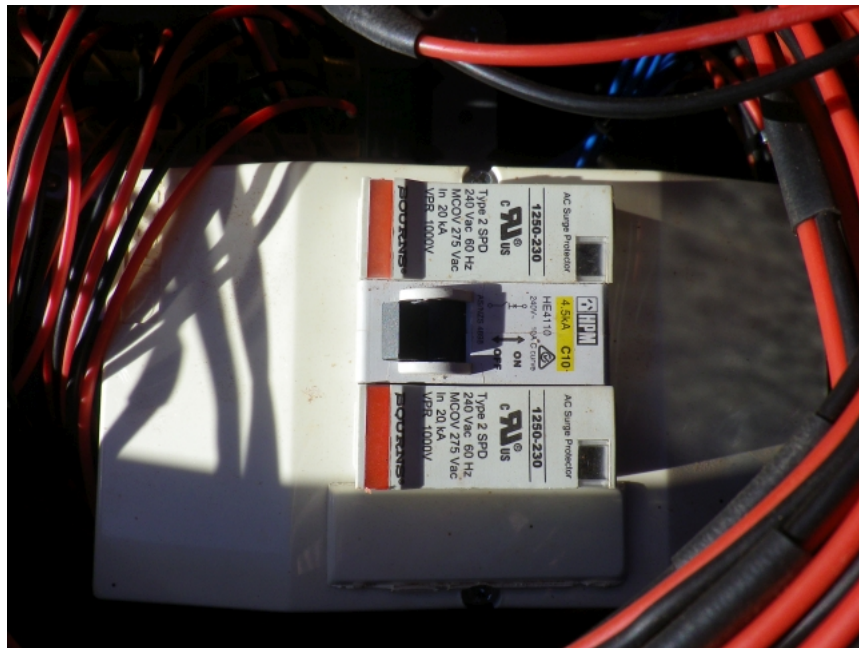
APIU internal breaker: HPM HE4110 => 4.5kA breaking capacity, "C" curve, 10A breaker.

FIGURE 4: APIU INTERNAL SUB-BOARD SHOWING BREAKER AND SURGE PROTECTORS

Attempting to turn on the APIU breaker failed (it tripped out immediately), and further caused the sub-board breaker to trip.

It is not clear whether the surge protection devices in the APIU have any effect on this recovery behaviour, and CIRA staff do not possess the necessary qualifications to isolate these devices in order to test any effect they may have.

Balance Utility Solutions (“Balance”) are best placed to analyse the above results/behaviours and recommend a suitable course of action to modify the installation to better handle up-stream power cycle operations without requiring complex re-start procedures.

In the ideal circumstance, no on-site activity should be required once the mains power is restored; the APIU should start up cleanly, even with all 256 antenna loads connected.
