**Title:** Re-laying LNA cabling at tile/beam-former

All tiles at the MRO

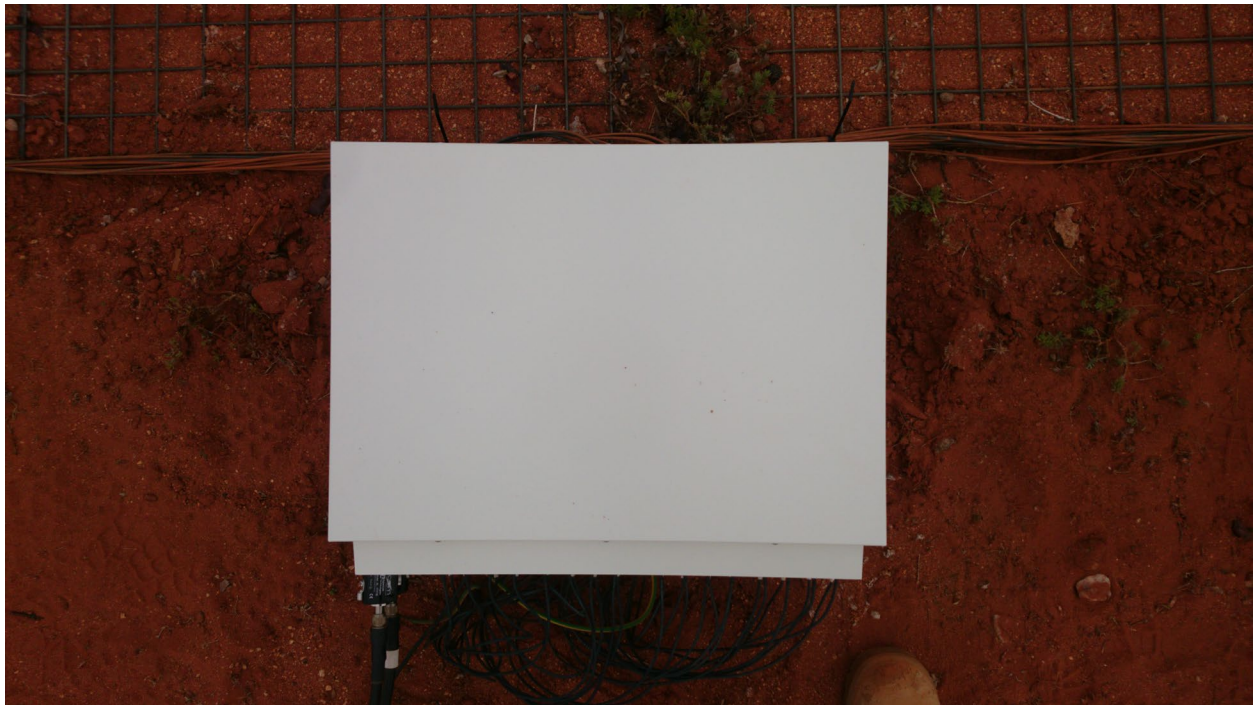
Over time we have observed LNA cable damage, apparently by being chewed by an unknown variety of animal. Apart from the damage to the cables themselves, an additional expensive consequence is that shorting the cable blows up the bias inductor in the front-end of the beam-former, rendering the corresponding input non-functional until the beam-former is also replaced.

**FIGURE 1: TOP VIEW OF NEW STYLE LNA CABLE MANAGEMENT**

In order to prevent the damage, we decided to try repositioning the beam-former closer to the edge of the tile mesh and coiling the excess LNA cables underneath the beam-former, thereby limiting access to exposed cables.

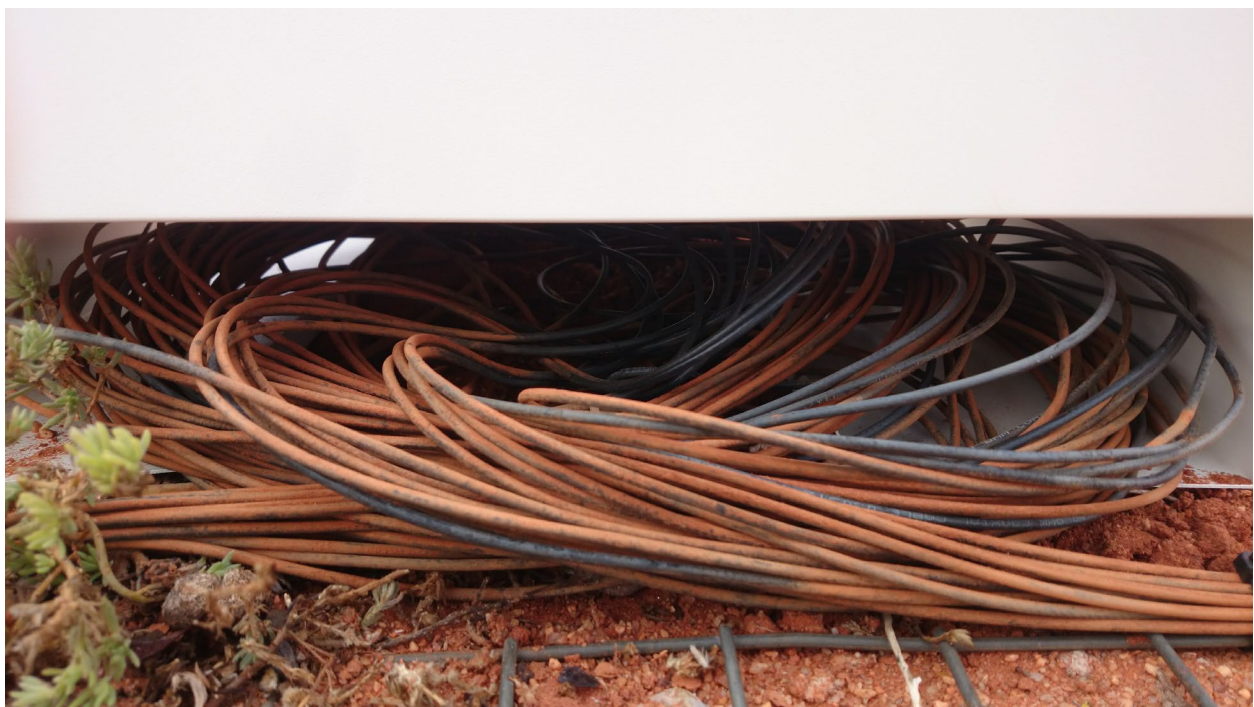
**FIGURE 2: VIEW UNDERNEATH BEAM-FORMER SHOWING CABLE BUNDLING**

Some further work needs to be done with this concept to ensure we avoid damaging the cables due to kinking as well as investigating other/additional methods of protecting the cables (eg. light mesh sheets or chicken wire covers over the cable bundles, etc.).
