Title: Covers to prevent rain entering lightning arrestors

All tiles at the MRO

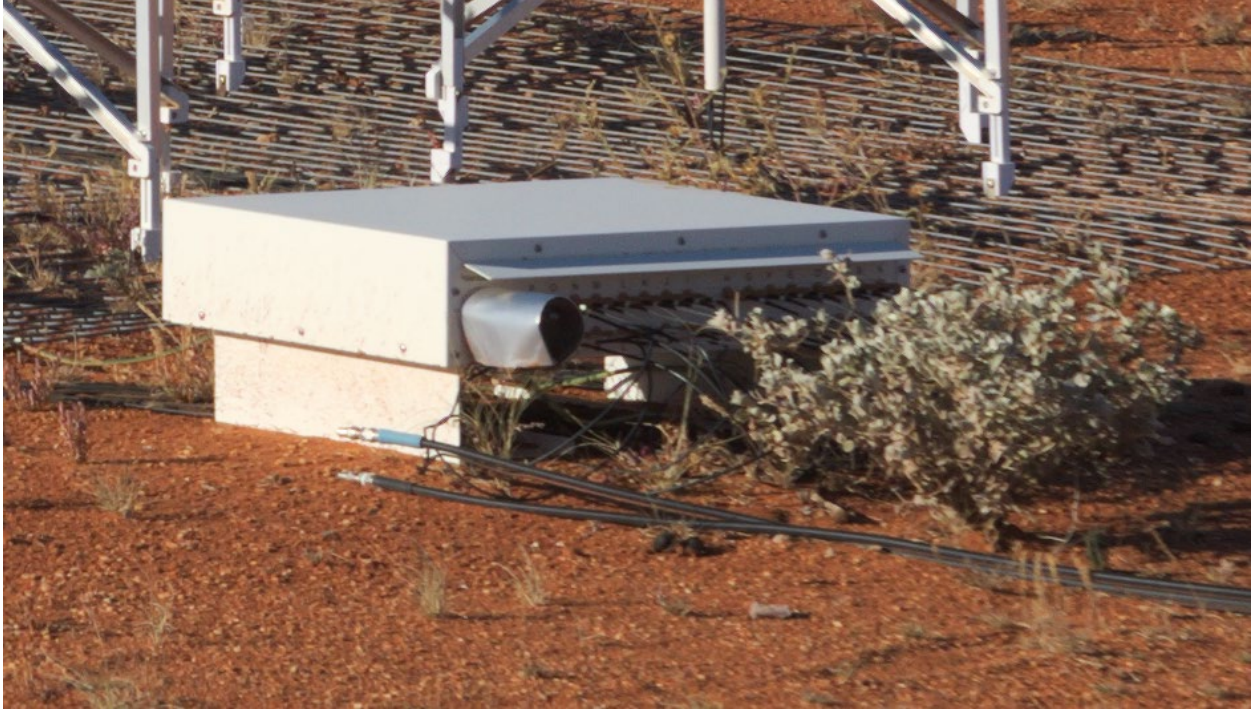
Some DoC cable failures seem to be caused by moisture ingress into the rear of the F-type connectors and it is possible that the path is via the lightning arrestors.

Photo Figure 1: Note the photo was taken after the tile was disconnected and ‘capped’ as part of MWA reconfiguration.

FIGURE 1: SHOWING HAND-FOLDED COVER OVER LIGHTNING ARRESTORS

A fairly simple fix seems to be to fold a small square (approx 150mm x 150mm) of thin aluminium flashing around the lightning arrestors on the face of the beam-formers to prevent direct rainfall from impinging on the RF connectors and lightning arrestors. The material is soft enough to easily take bends and folds by hand. Product available from Bunnings, item number 1100454 – 150mm wide, 0.3mm thick WeatherFlash roll, 20m long.
