## **ENGINEERING MEMO**

## Title: Impact of seasonal rains around the Curtin MRO site

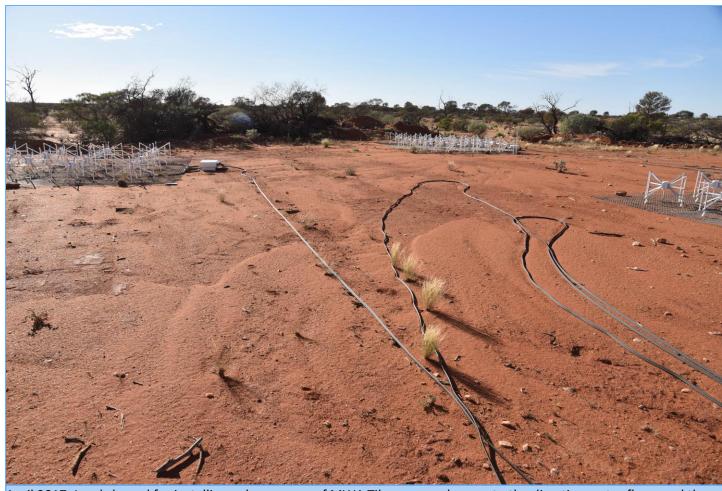
Jan 2018: Long baseline Tile F4 is adjacent to a creek, and suffered mild damage.

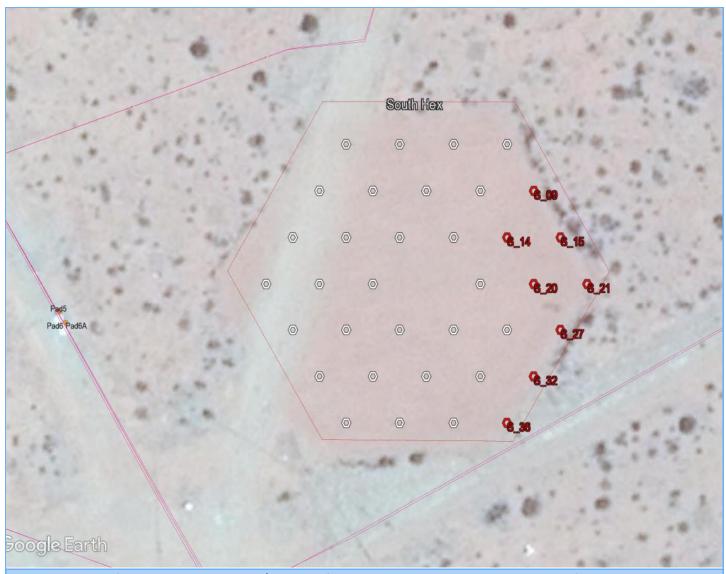
April 2017: Land cleared for installing a dense array of MWA Tiles causes changes to the direction water flows and the locations that the water pools. The result of this caused damage to the equipment in the newly formed flood plain.

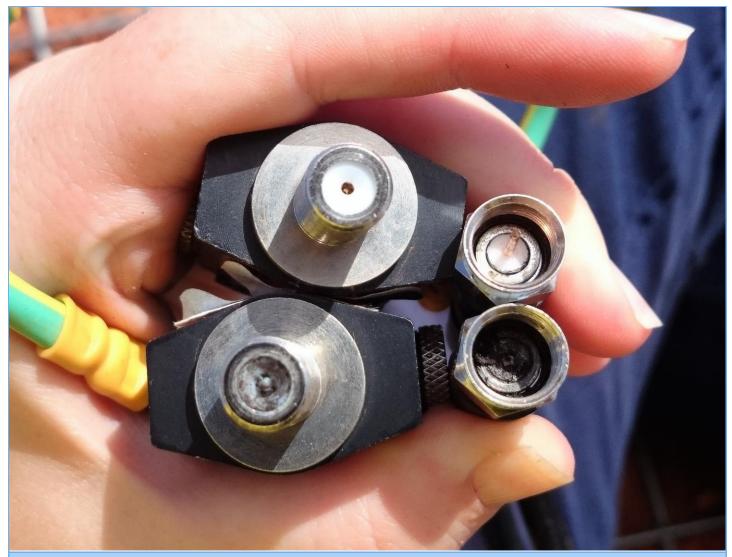
April 2017: There was evidence of a higher water flood level on multiple beamformers in the Southern hex.

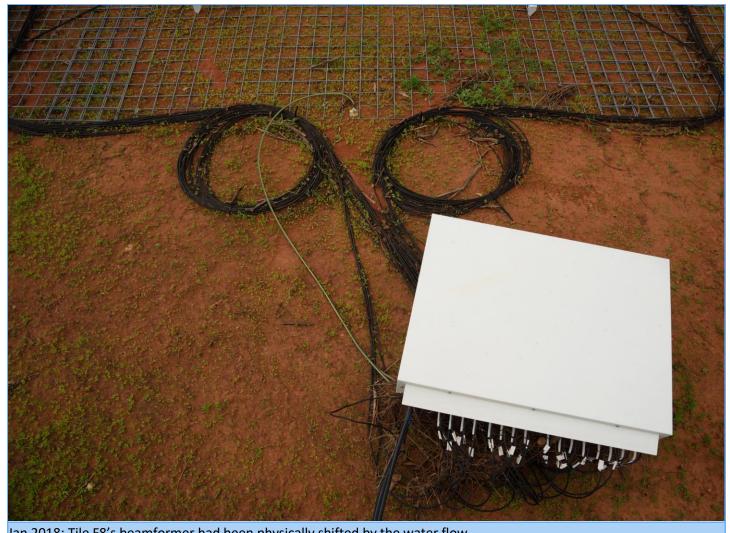
Jan 2018: Long baseline Tile F8 was downstream of a wide creek bed, and suffered substantial damage. Surrounding trees helped to block the tile from some of the debris.

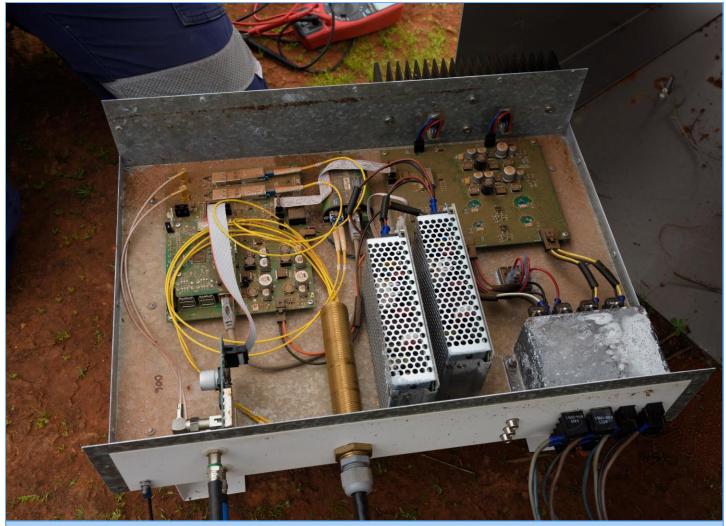
Jan 2018: Tile F8's batteries had been completely submerged. The height of these batteries is 240mm, indicating a flood level of at least 220mm.
